# Environmental Impact Assessment on Central Catchment Nature Reserve for the Proposed Cross Island Line

FINAL CONSTRUCTION & OPERATION ENVIRONMENTAL IMPACT ASSESSMENT REPORT – VOLUME II

Final Construction & Operation EIA – *Volume II*

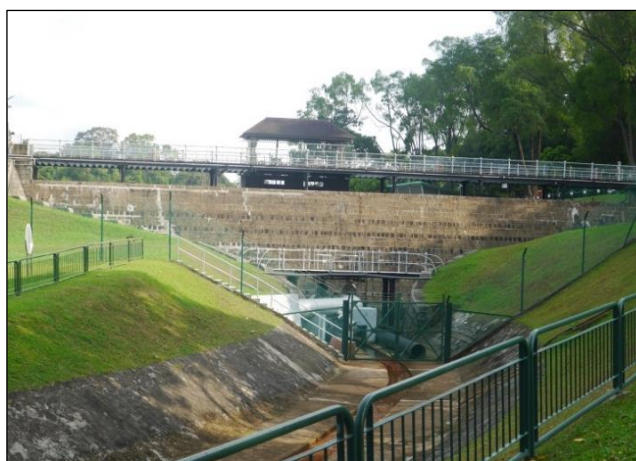
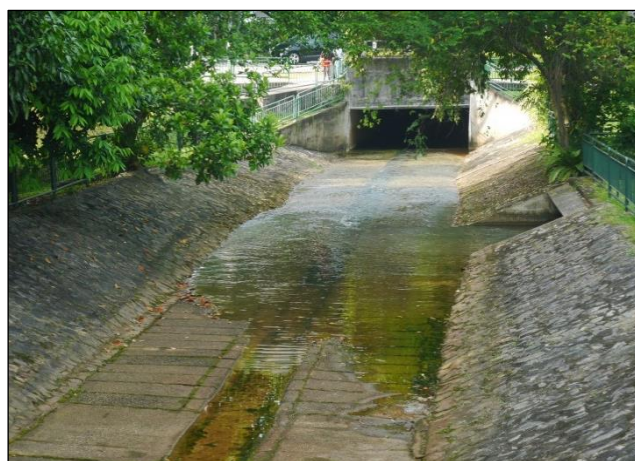
*Dam and outfall of MacRitchie reservoir, near Reservoir Road*

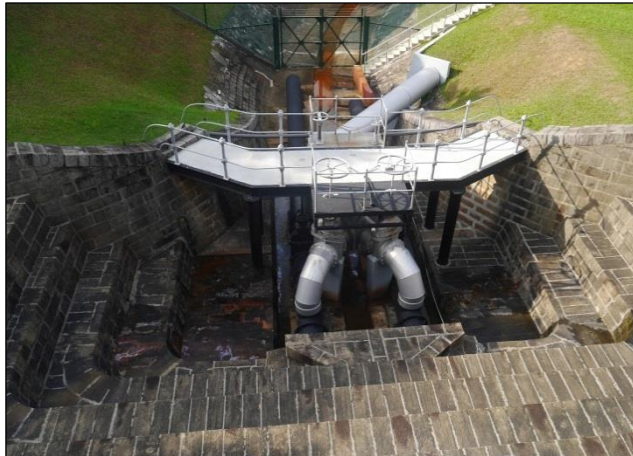
*View of reservoir's outfall from the dam*

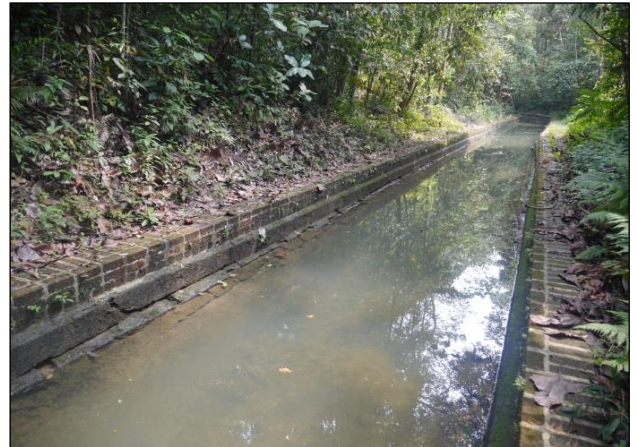
*Stream Hd and PUB reservoir interchange waterway*

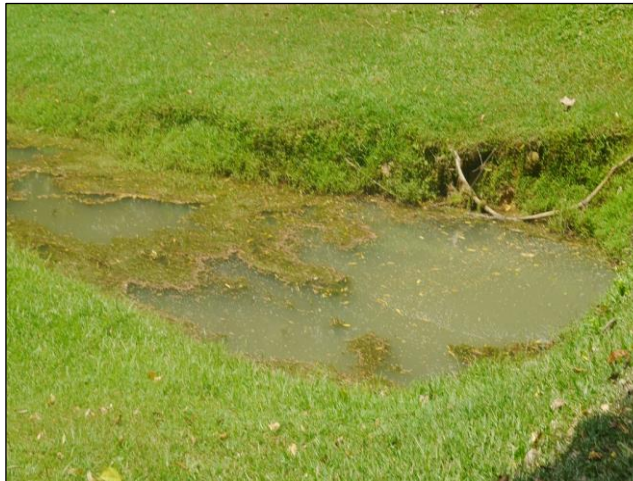
*Aquatic Plant and Algal Blooms*

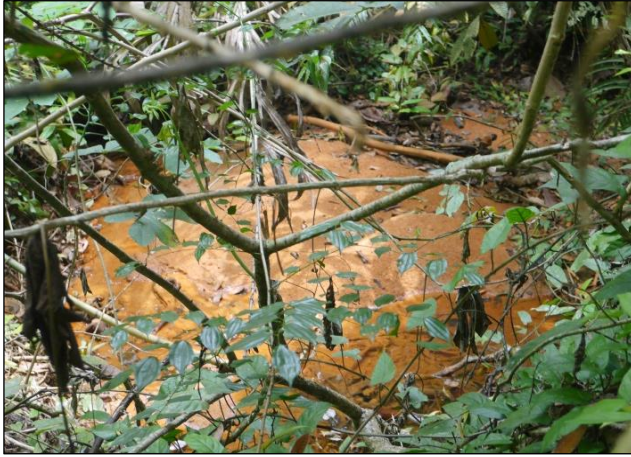
Surface Water Sampling Location SW101

Sampling Point ID	Location	Rationale
SW 101	Along Rifle Range Link within CCNR	Representative of water quality upstream of stream I
SW 102	At the bridge along Sime Track, near western perimeter of CCNR and SICC Bukit Golf Course	Representative of water quality upstream of proposed SI locations
SW 103	At the bridge next to Golf Link, near western perimeter of CCNR and SICC Bukit Golf Course	Representative of water quality downstream of proposed SI locations, and water quality downstream of stream I
SW 104	Next to Dillenia Hut within CCNR	Representative of water quality upstream of stream Hd
SW 105	At the bridge near the junction of Sime Track and Rifle Range Link (within CCNR)	Representative of water quality downstream of proposed SI locations, and water quality downstream of stream Hd
SW 106	Along Sime Track, near Petaling Hut (within CCNR)	Representative of water quality downstream of proposed SI locations, and water quality downstream of stream Ha

At each location, surface water samples were retrieved by a decontaminated disposable bailer and transported to a SAC-SINGLAS certified laboratory for analysis of the suite of parameters mentioned in *Table 5.5*. Samples were collected from streams or water bodies from existing trails and from the stream bank, i.e. there was no physical entry into streams. Prior to sampling at a new stream/water body, all field equipment was rinsed using water from the sampling site, and clean gloves were worn to avoid potential contamination of the samples.

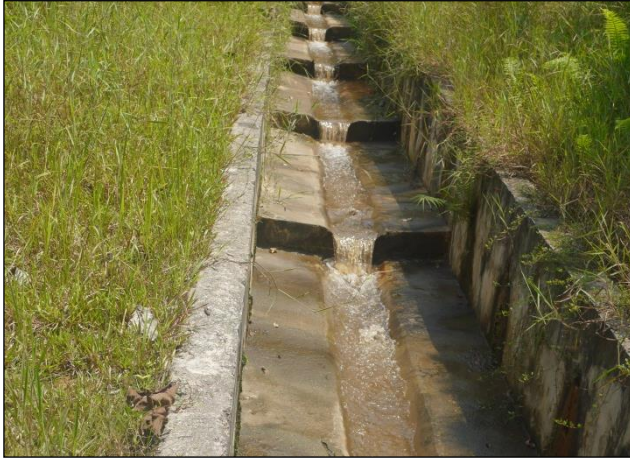
Surface Water Sampling Location SW107

SW 107	Along Sime Track, at the side of Terentang Hut (within CCNR)	Representative of water quality upstream of proposed SI locations, and water quality upstream of stream Ha
SW 108	Along Venus Link	Distinct aquatic environment
SW 109	Within SICC Island Golf Course	Distinct aquatic environment

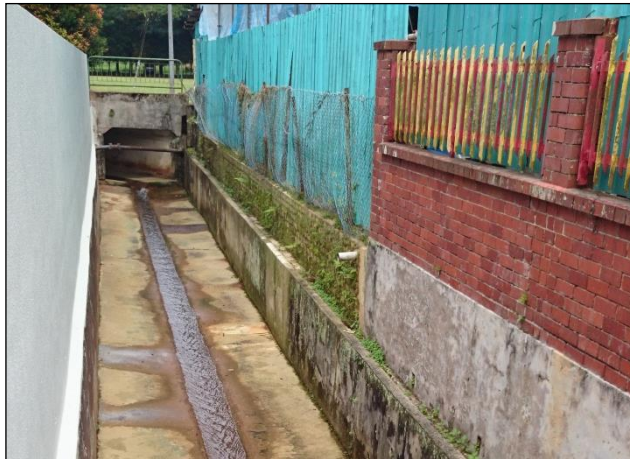
Surface Water Sampling Location SW201

Sampling Point ID	Location	Rationale
SW 201	Along Windsor Park Road	Representative of water quality upstream of proposed SI locations
SW 202	Along Upper Thomson Road, between Windsor Park Road and Gardenia Road	Representative of water quality downstream of proposed SI locations
SW 203	Between Island Landscape & Nursery, and the cross junction of Thomson Road and Upper Thomson Road	Representative of water quality downstream of potential SI work and the proposed vent building near the junction of Thomson Road and Upper Thomson Road
SW 204	Between Reservoir Road and the cross junction of Thomson Road and Upper Thomson Road	Representative of water quality upstream of potential SI work and the proposed vent building near the junction of Thomson Road and Upper Thomson Road

At each location, surface water samples were retrieved by a decontaminated bailer and transported to a SAC-SINGLAS certified laboratory for analysis of a suite of parameters outlined in *Section 5.7*. Samples were collected from the canals, while standing near or on the existing trails and from the bank, i.e. there was no entry into the water. Prior to sampling at a new stream/water body, all field equipment was rinsed using water from the sampling site, and clean gloves were worn to avoid potential contamination.

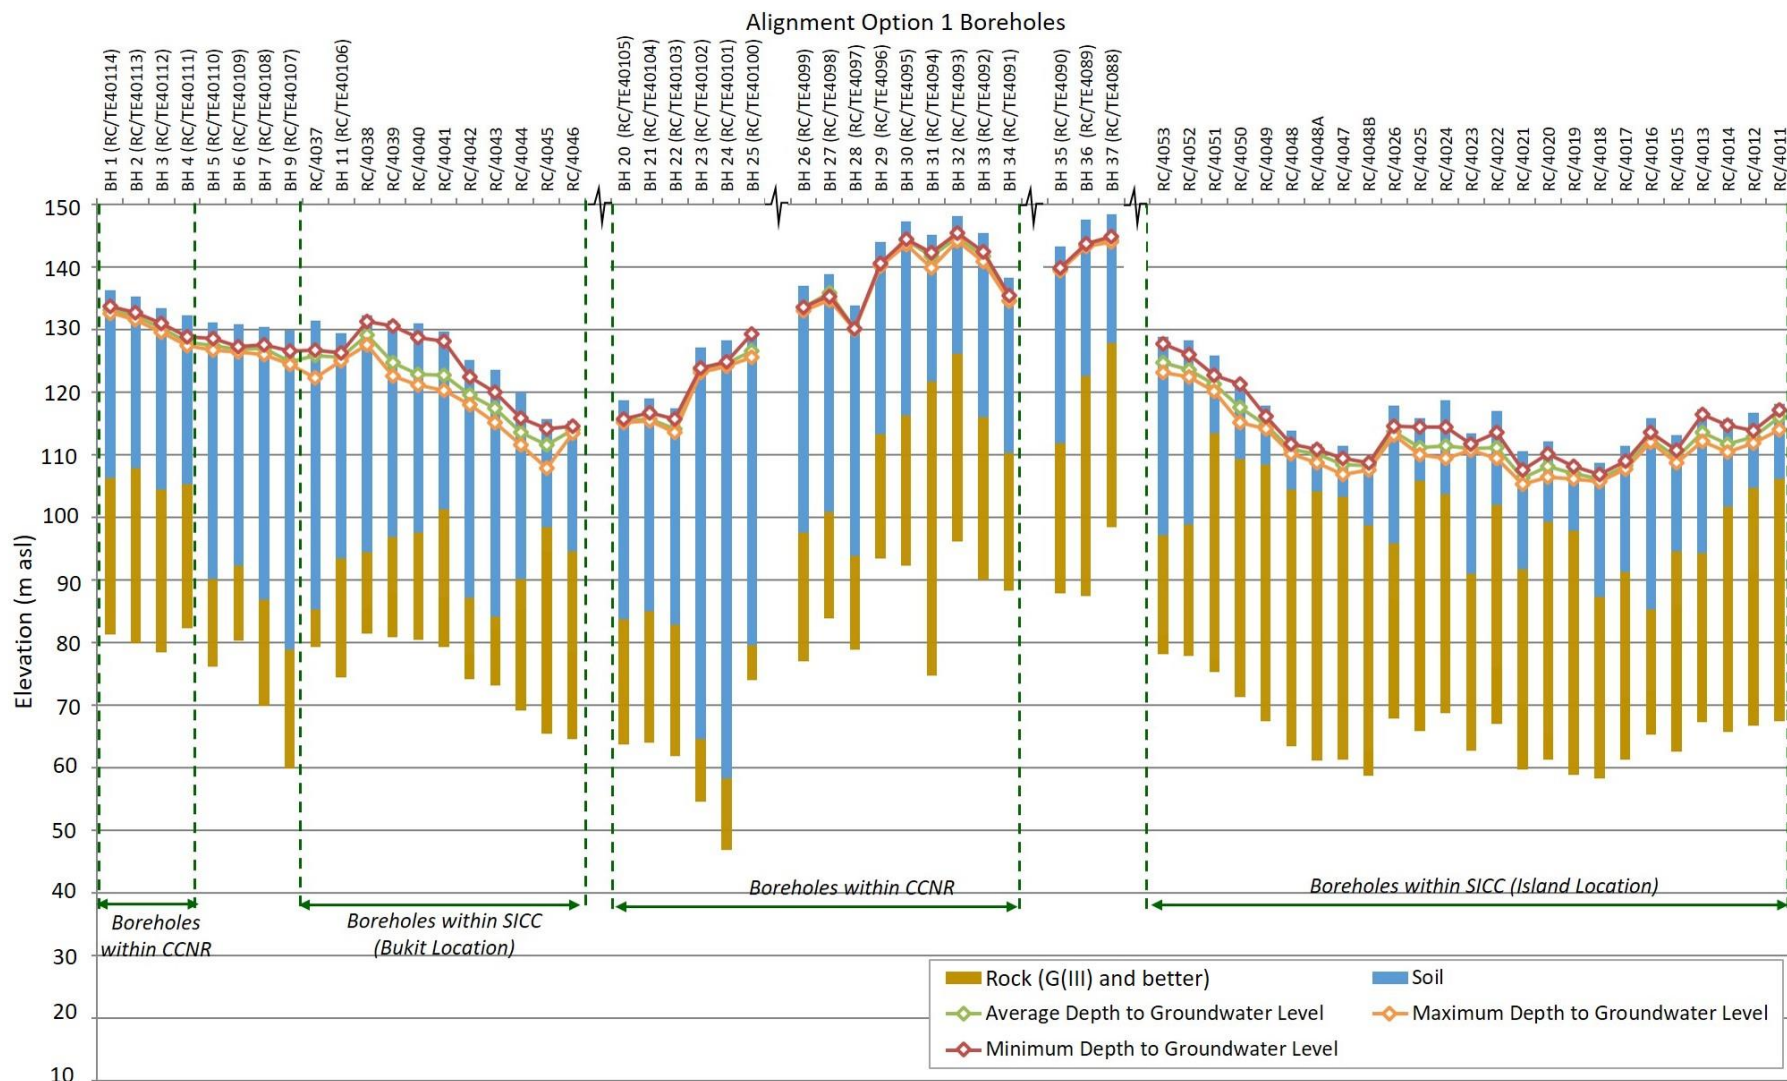
**Figure 5.4: Available Water Level Data Collected during Drilling and Lithology Summaries for Boreholes along Alignment Option 1**

Note 1: Boreholes are arranged not to horizontal scale and gaps between borehole locations indicate greater than typical distance horizontally between locations.

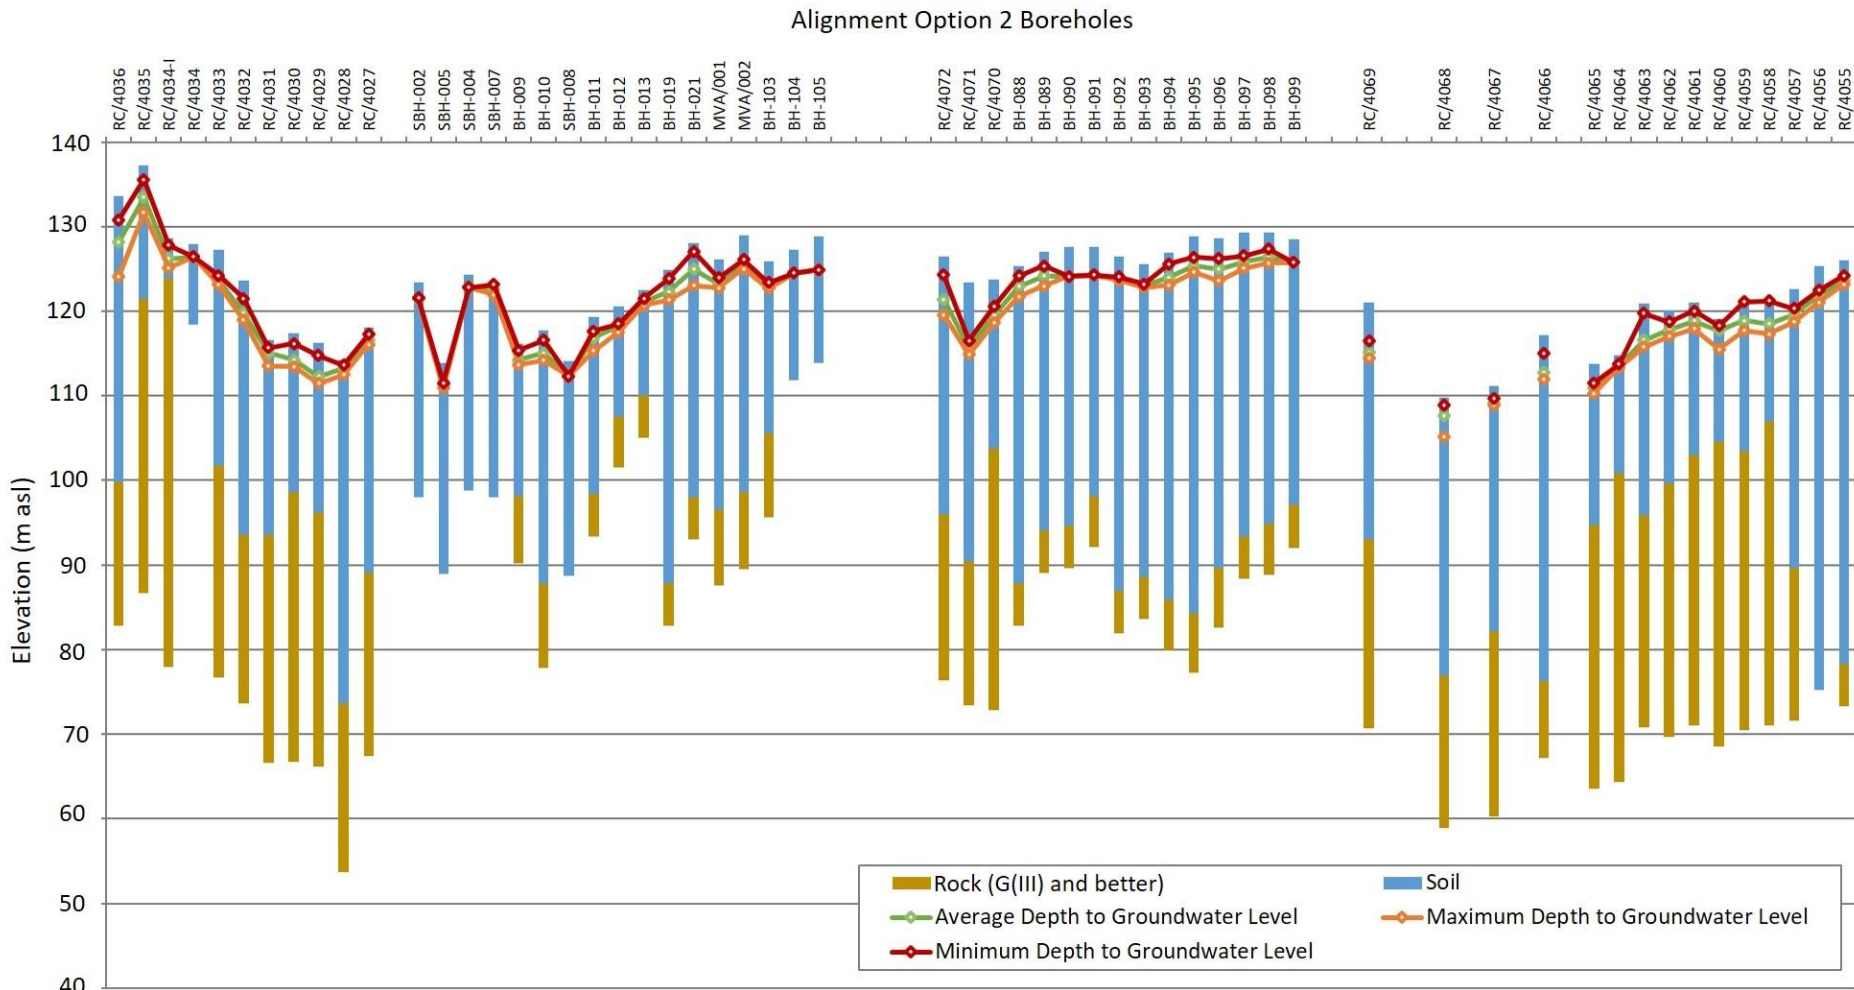
Figure 5.5: Available Water Level Data Collected during Drilling and Lithology Summaries for Boreholes along Alignment Option 2

Note 1: Boreholes are arranged not to horizontal scale and gaps between borehole locations indicate greater than typical distance horizontally between locations.
